# Pavement Condition Survey & Pavement Management Report for City of Harker Heights

## Harker Heights, TX

### Final Report

December 17, 2025

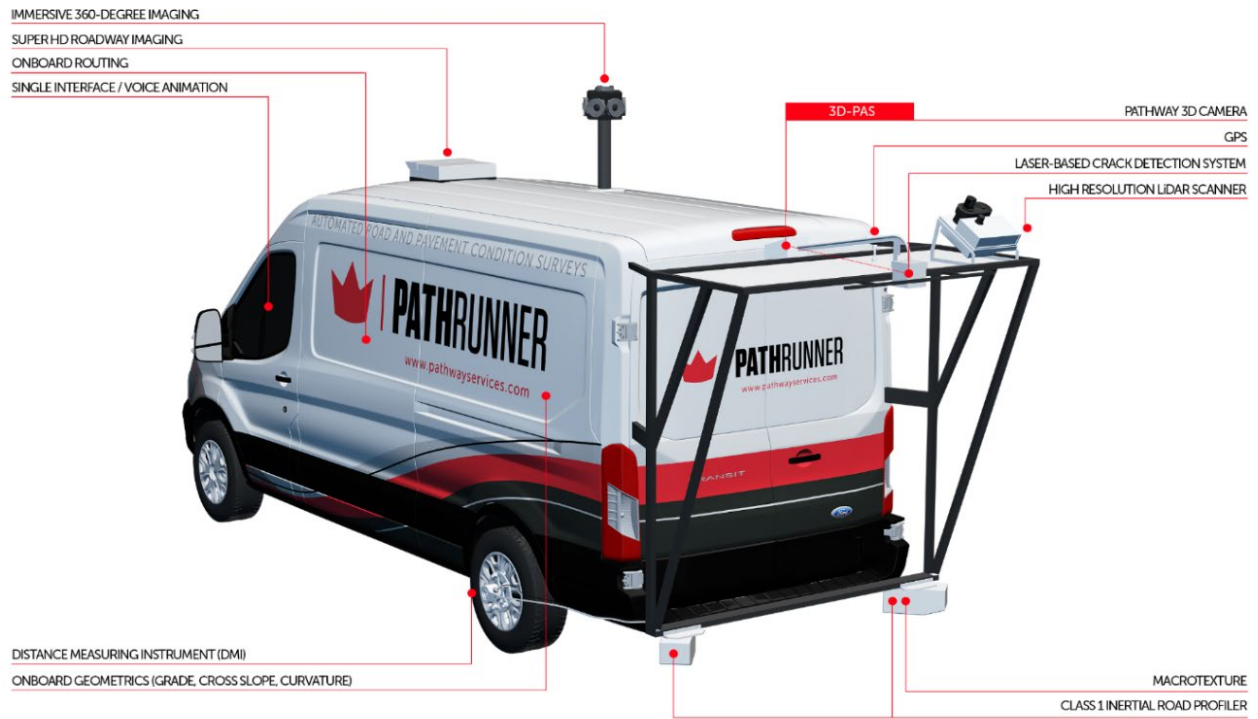
**Figure 2: PathRunner Hardware Components**

The pavement survey vehicle is equipped with industry standard sensors and hardware required for accurate, high-quality pavement data collection, including:

1. **3D Pavement Imaging Sensor:** This sensor captures detailed images and measurements of the pavement surface in three dimensions, which is crucial for assessing pavement conditions such as cracking, rutting, and surface texture.

2. **360° Ladybug Camera:** The Ladybug camera provides panoramic images, allowing for a comprehensive view of the surrounding environment. This can be useful for contextual information and for documenting the conditions around the surveyed area.

3. **Right of Way (ROW) Cameras:** With multiple ROW cameras, the vans can capture panoramic images along the sides of the road. These images are valuable for documenting the conditions of the roadside and surrounding infrastructure.

4. **High-Definition, 3D LIDAR System:** LIDAR (Light Detection and Ranging) technology is used to create detailed 3D maps of the road surface and surroundings. It's capable of precise measurements and can detect subtle changes in elevation and surface features and can be utilized for right-of-way asset feature extraction.

5. **Class-1 Roadway Surface Profiler:** This profiler measures macrotexture of the road surface. Macrotexture affects skid resistance and drainage, both important factors for pavement safety and durability.

The 3D Pavement Imaging Sensor system allows automated detection of pavement distresses including various types of cracks, raveling, edge drop-offs, potholes, macrotexture, and rutting. The system also automatically determines the presence of paint stripes which help in identifying the pavement lane. A picture of the ARA-owned PathRunner with the 3D Pavement Imaging

System is shown in Figure 2. Sample pavement images are shown in Figure 3. Data collection was performed during daytime and under prevailing traffic conditions.

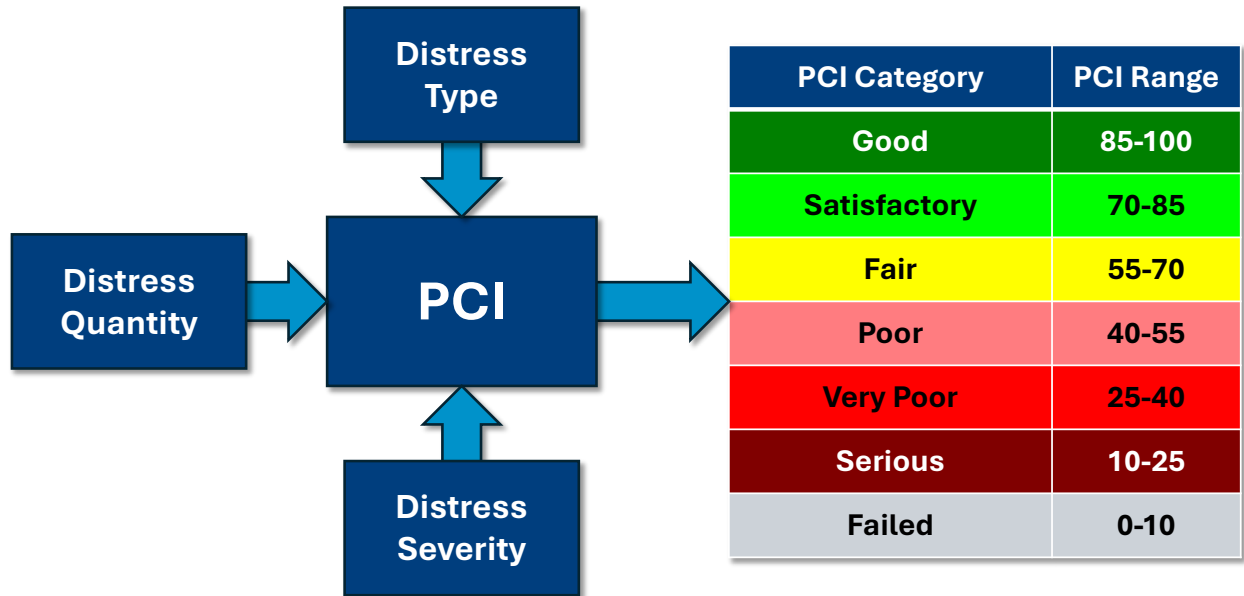
*Figure 5: PCI Condition Categories used in this Project.*

The project’s condition assessment scale is shown in Figure 5. PCI scores range from 0 to 100, with 0 representing the worst pavement condition and 100 representing the best possible condition. If properly designed and constructed, new pavements begin their service life with a PCI of 100. Due to the effects of loading and aging, the pavement deteriorates over time and its PCI decreases. To obtain a section’s PCI, the type, extent, and severity of pavement distresses are recorded on representative samples and are used to calculate a deduct value. PCI is calculated through subtracting the deduct values from 100, and its PCI decreases. Pavement management software, including PAVER, calculate the PCI scores for each pavement section based on a combination of distress types, severities, and quantities.

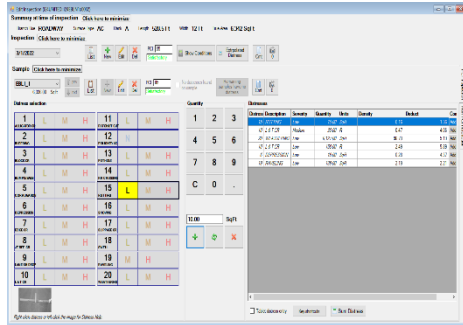
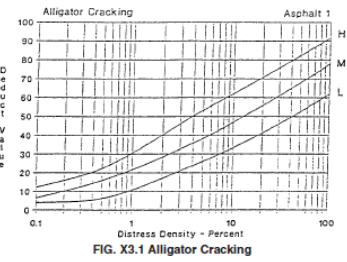
Detailed pavement distress (type, severity and extent) data were imported into the U.S. Army Corps of Engineer’s PAVER software to calculate PCI scores for each segment. PAVER calculates the PCI score for each ‘sample unit’ (for this project approx. 2400 sq. ft), and then calculates an area weighted average PCI value for the pavement section. An overview of the PCI calculation process is shown in Figure 6. The steps involved are as follows:

1. In each Sample Unit, distresses are recorded along with their types, severity levels and extents (quantities)
2. Deduct values are calculated and the distresses are sorted in descending order.
3. Through an iterative process, the cumulative deduct values are calculated.
4. The final PCI score for the Sample Unit is calculated as  $100 - (\text{max}) \text{ cumulative deduct value}$ .
5. Section PCI score is calculated as the area weighted average of individual Sample Unit PCI scores in that section.

$$m = 1 + (998)(100 - 25.1) = 79 < 8$$

Use highest 7 deducts and 0.9 of eighth deduct.  
0.9 x 5.1 = 4.8

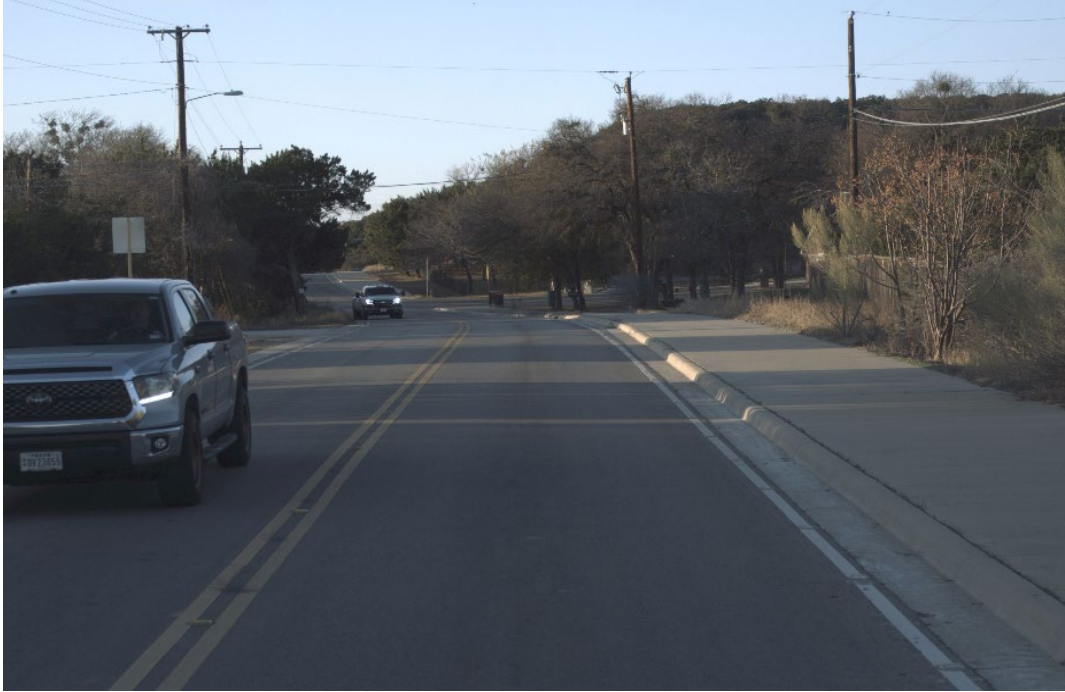
**Figure 7: COMANCHE GAP RD (PCI=98.7, Good Condition)**

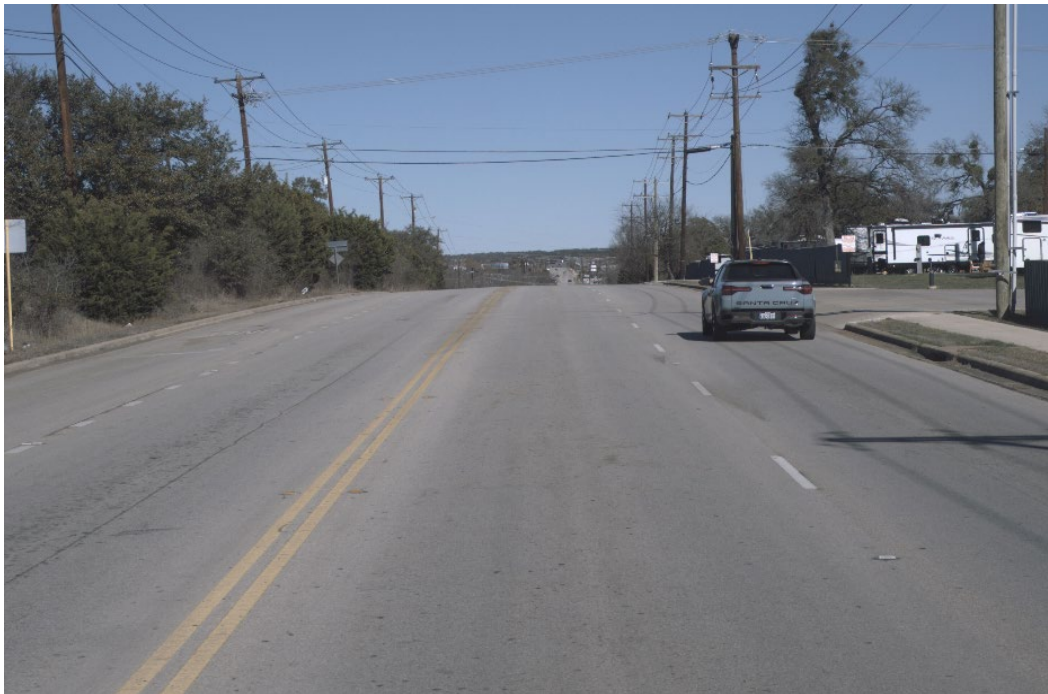
**Figure 8: N ROY REYNOLDS DR NB (PCI=89.1, Good Condition)**

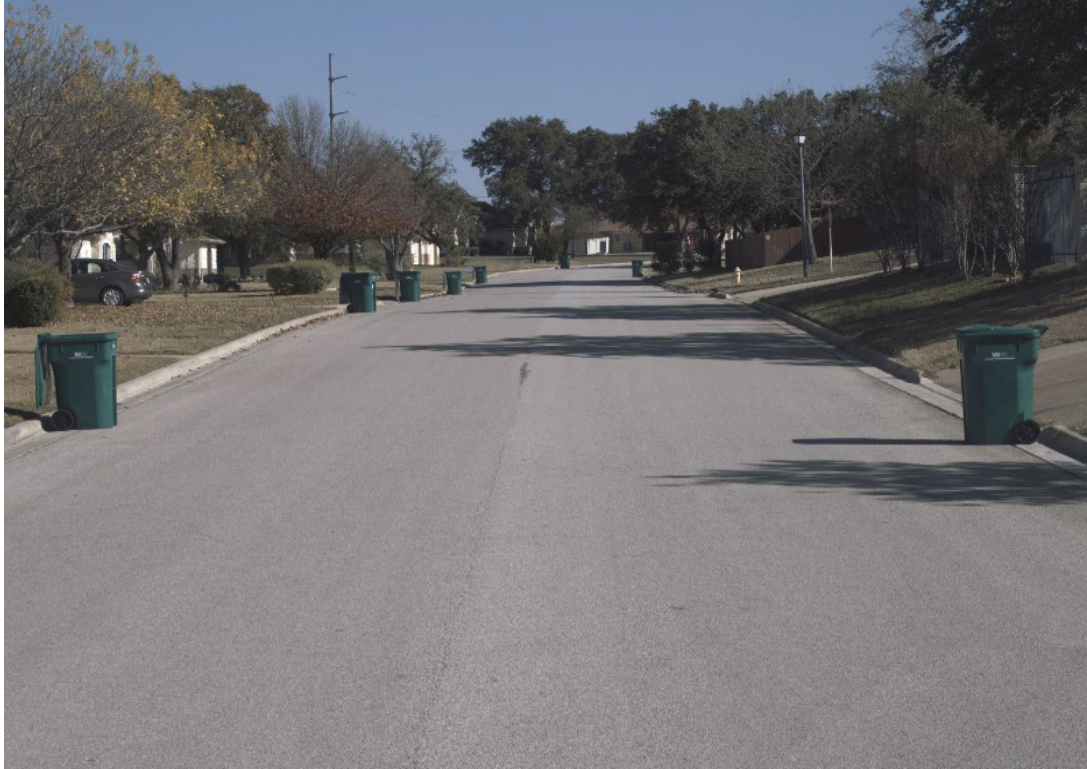
**Figure 9: CATTAIL CIR (PCI=79.4, Satisfactory Condition)**

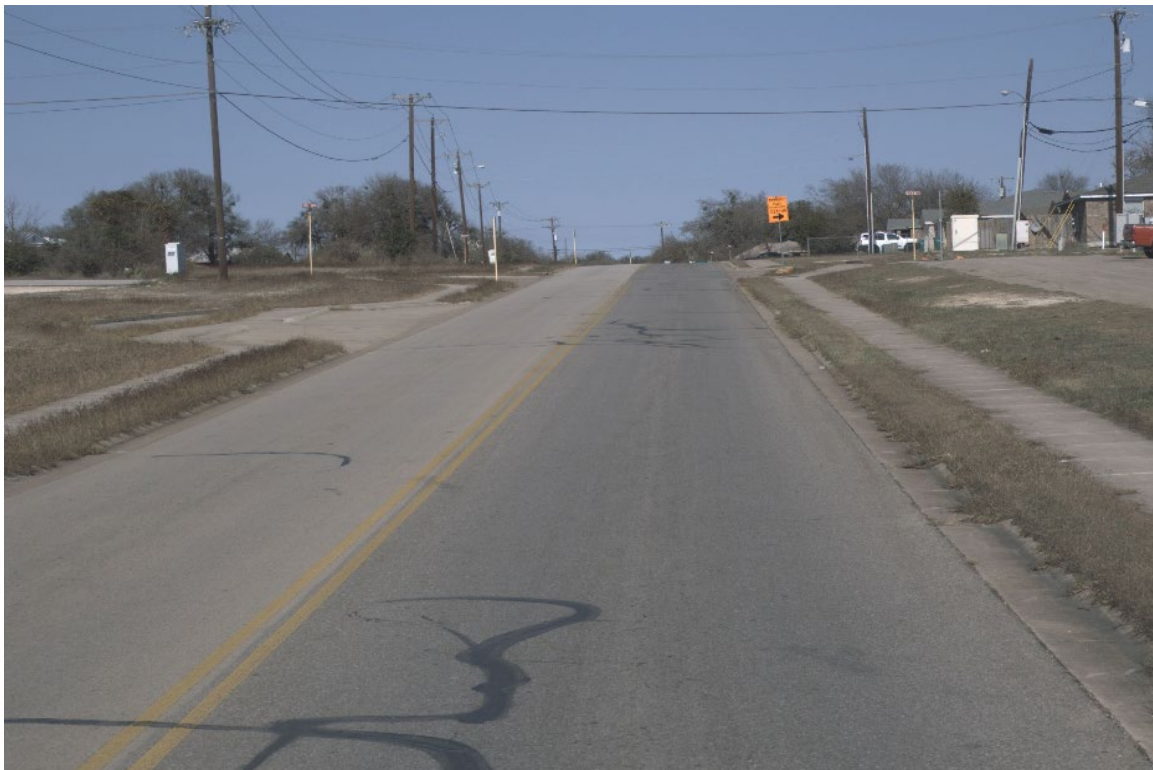
**Figure 10: INDIAN TRAIL DR (PCI=76.3, Satisfactory Condition)**

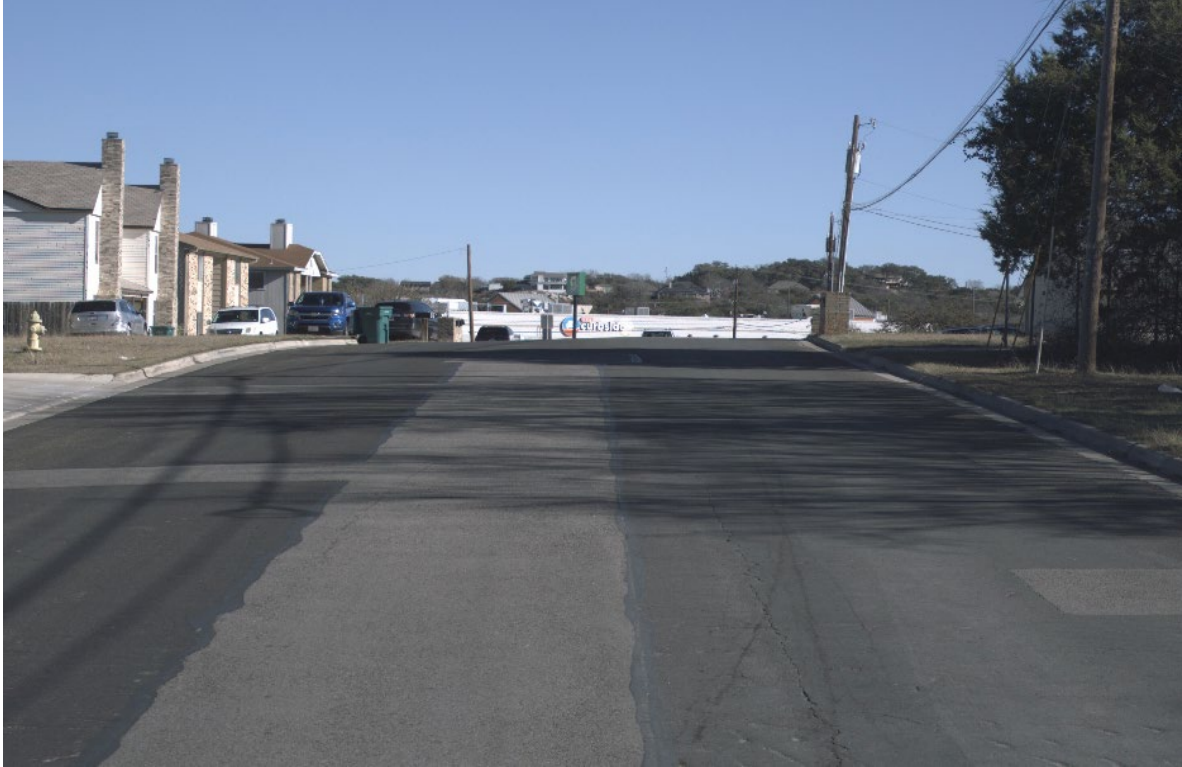
*Figure 11: E BEE LINE LN (PCI=69.2, Fair Condition)*

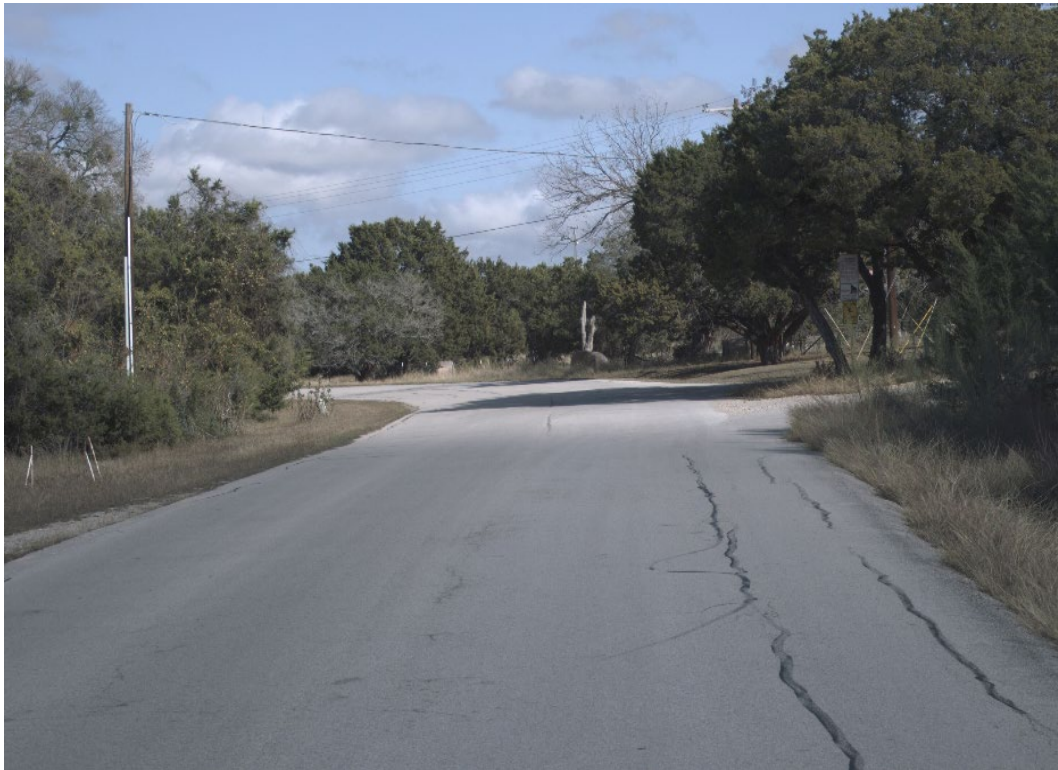
*Figure 12: OAKRIDGE BLVD (PCI=60.5, Fair Condition)*

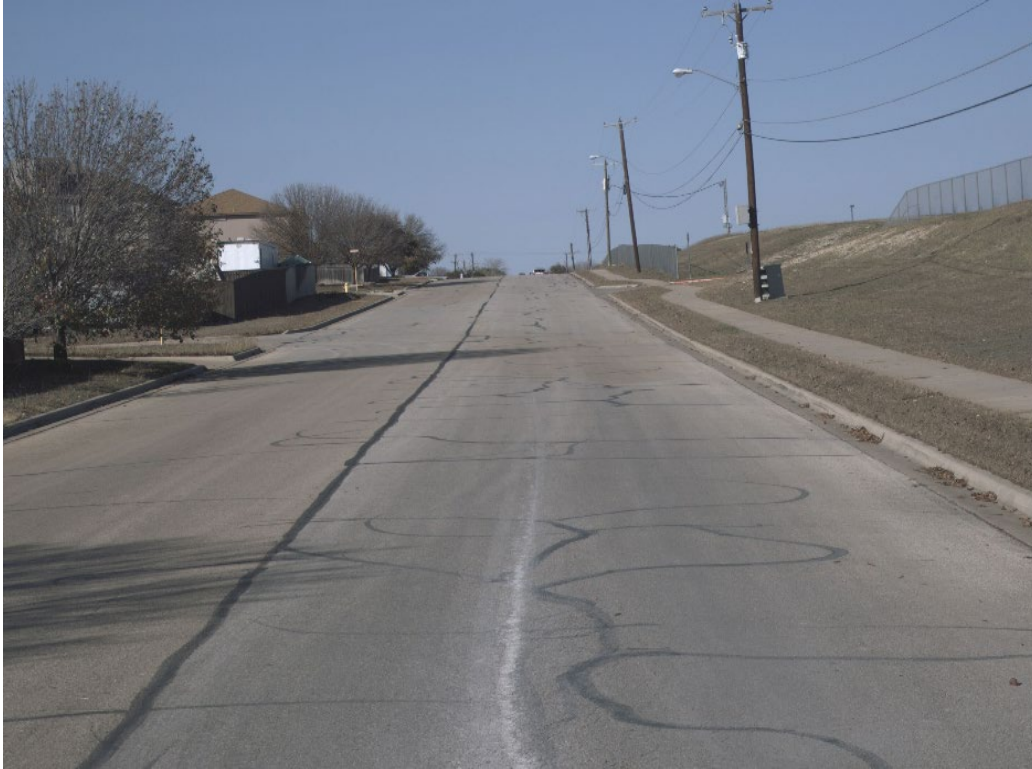
*Figure 13: MODOC DR (PCI=46.2, Poor Condition)*

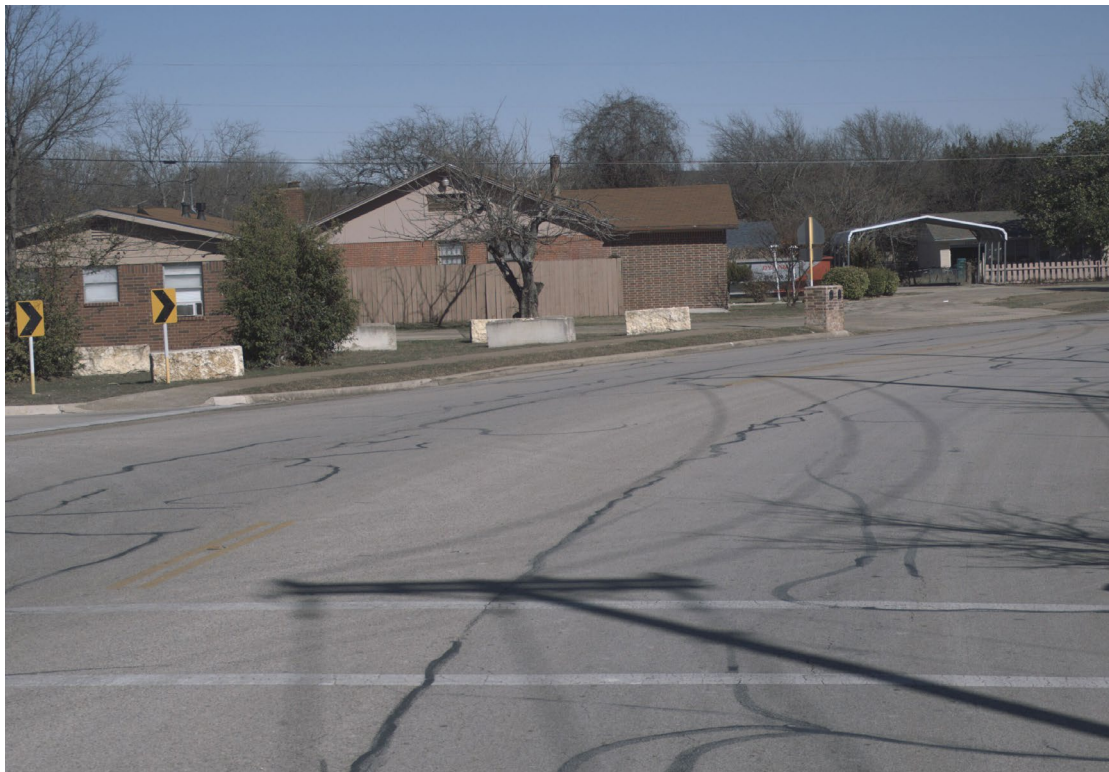
*Figure 14: S ANN BLVD (PCI= 43, Poor Condition)*

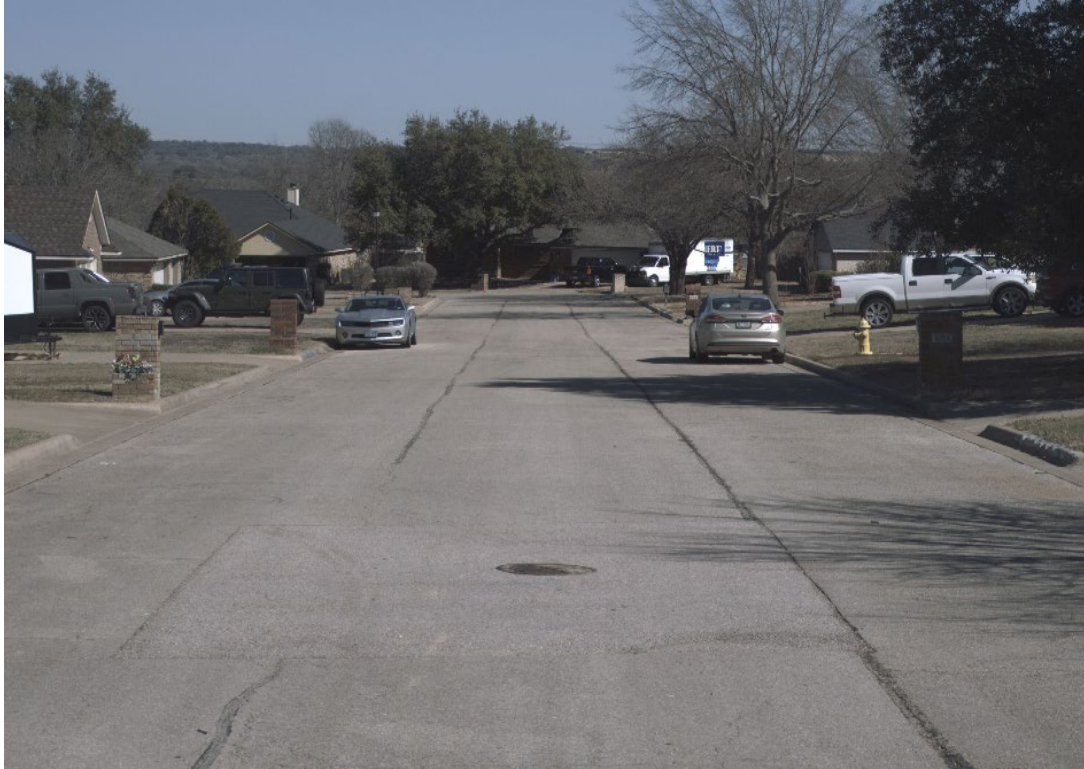
**Figure 15: CITATION LOOP (PCI=29.2, Very Poor Condition)**

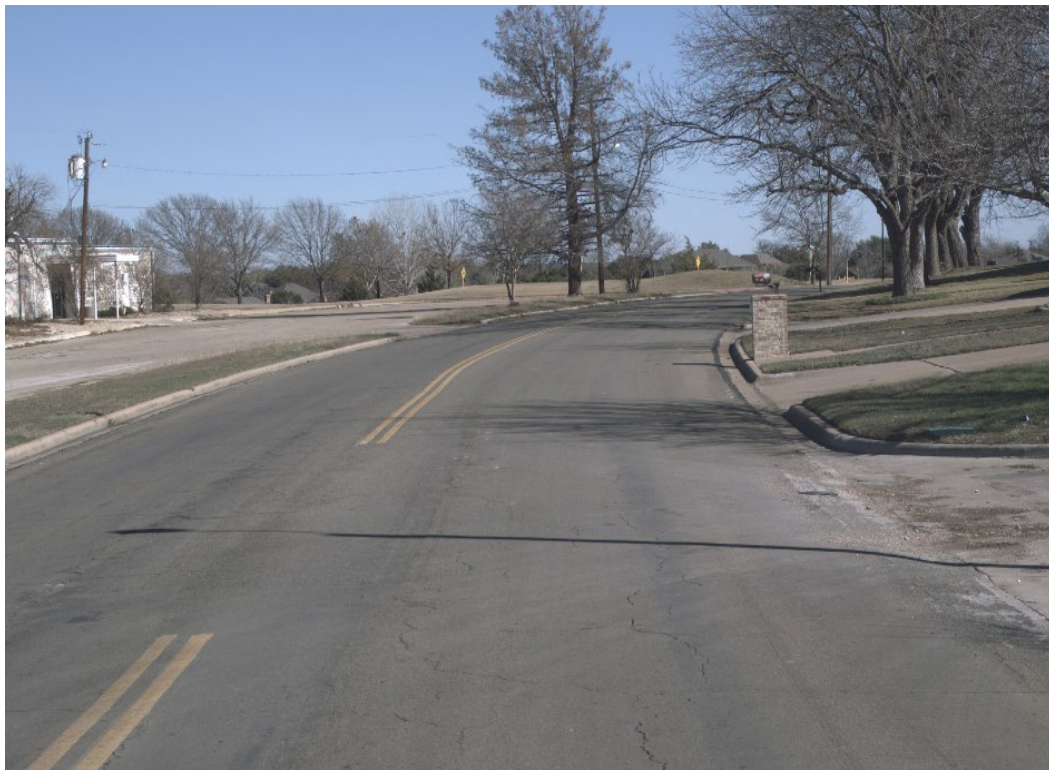
**Figure 16: S ROY REYNOLDS DR (PCI= 38.1, Very Poor Condition)**

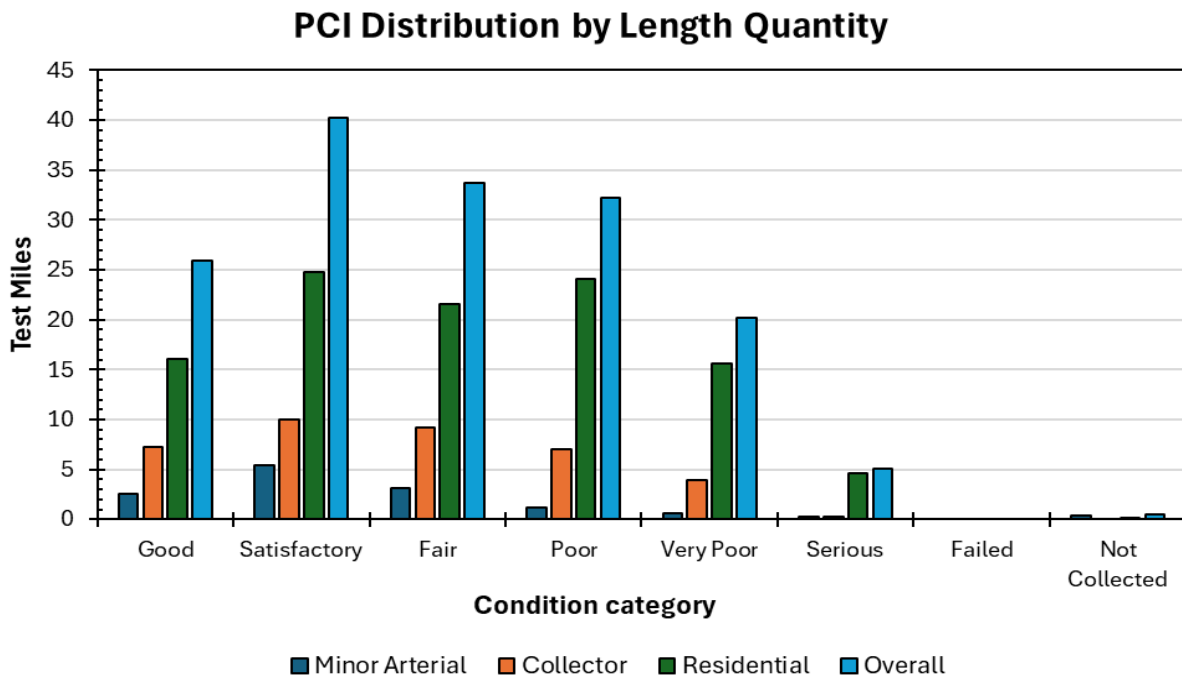
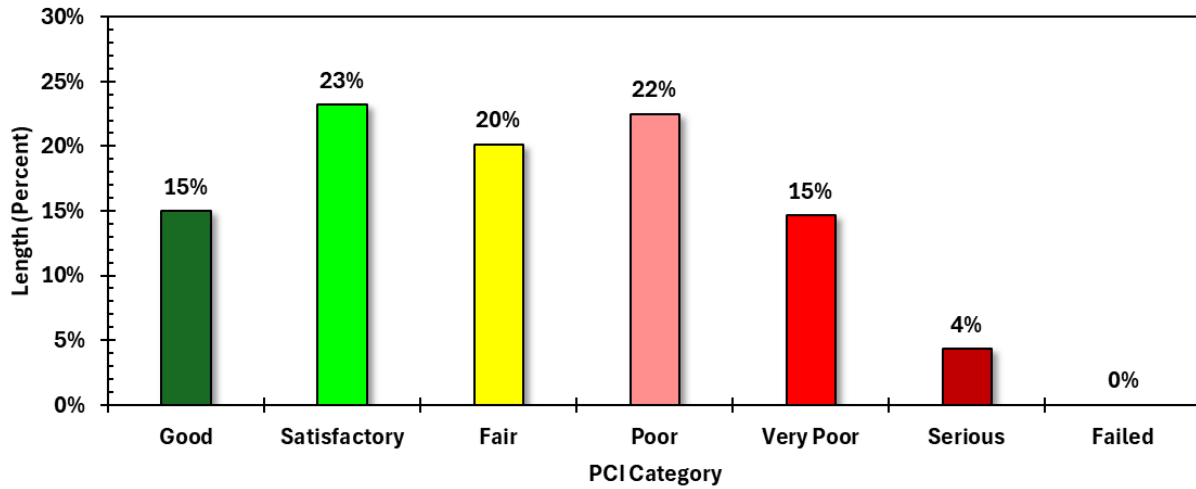
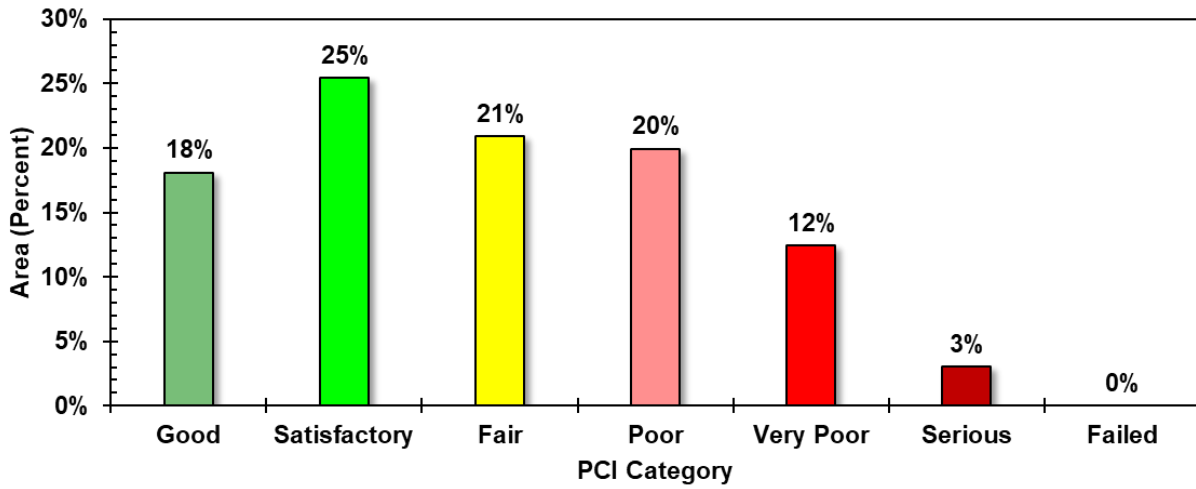
The PCI data are also shown in Table 6 and graphically Figure 18 to Figure 20. Arterial roads were tested in two directions (2 test miles per centerline mile) and collector & residential roads were tested in one direction (1 test mile per centerline mile)

**Figure 18: Overall Pavement Condition- PCI (Miles)**

Figure 19: Percent by Length based on Pavement Condition Index (PCI)

Figure 20: Percent by Area based on Pavement Condition Index (PCI)

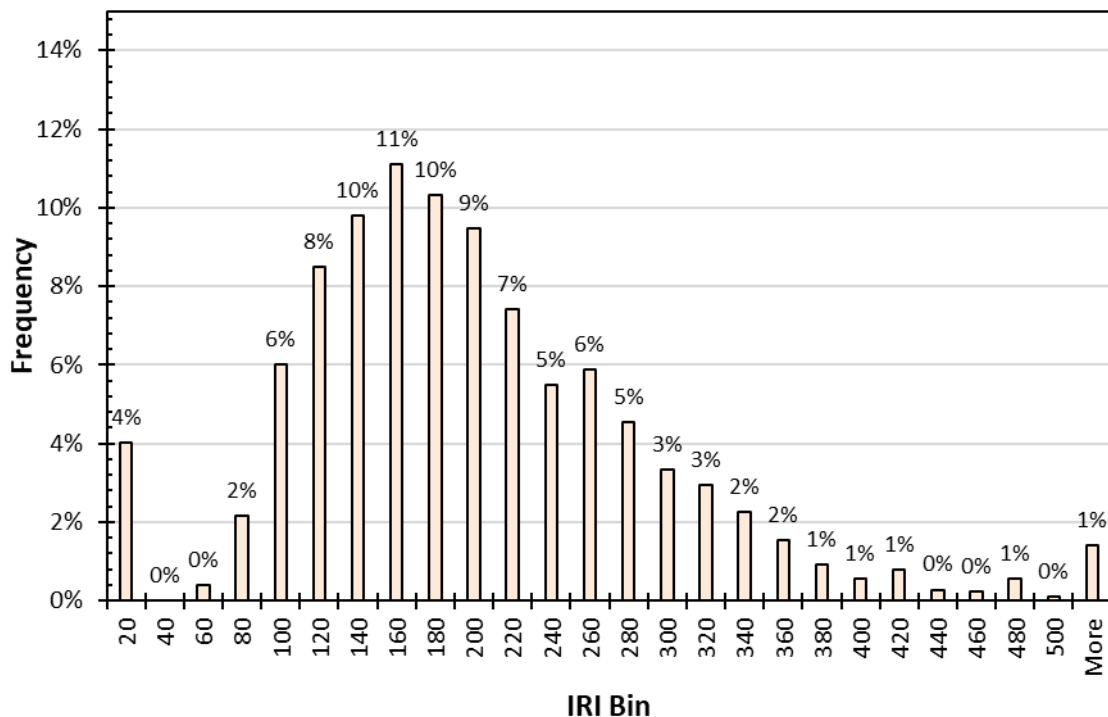
**Figure 21: IRI Distribution Histogram**

Figure 21 below presents the International Roughness Index (IRI) distribution for the City’s roadway network. In addition, Figure 22 presents the plots of the IRI and the cumulative percentage for local roads and for the overall network. It should be noted that IRI was filtered out where the data collection speed was less than 15 mph. The reason for this is because when collection speeds drop below 15 mph, the measured IRI values are not considered as accurate when collected above this speed. This is a known and documented limitation of IRI measurements. This resulted in some sections with no reportable IRI value.

Most pavement sections have IRI between 100 and 240 inches/mile, as shown in Figure 21 below. Figure 22 shows that the minor arterial roads have significantly lower IRI values (which means better ride quality), than collectors or residential roadways and the network. Figure 23 demonstrates the typical ranges for IRI values by pavement function as classified in “The Little Book of Profiling”. Generally, roads with higher PCI values also have lower IRI values, but this is not absolute in every situation.

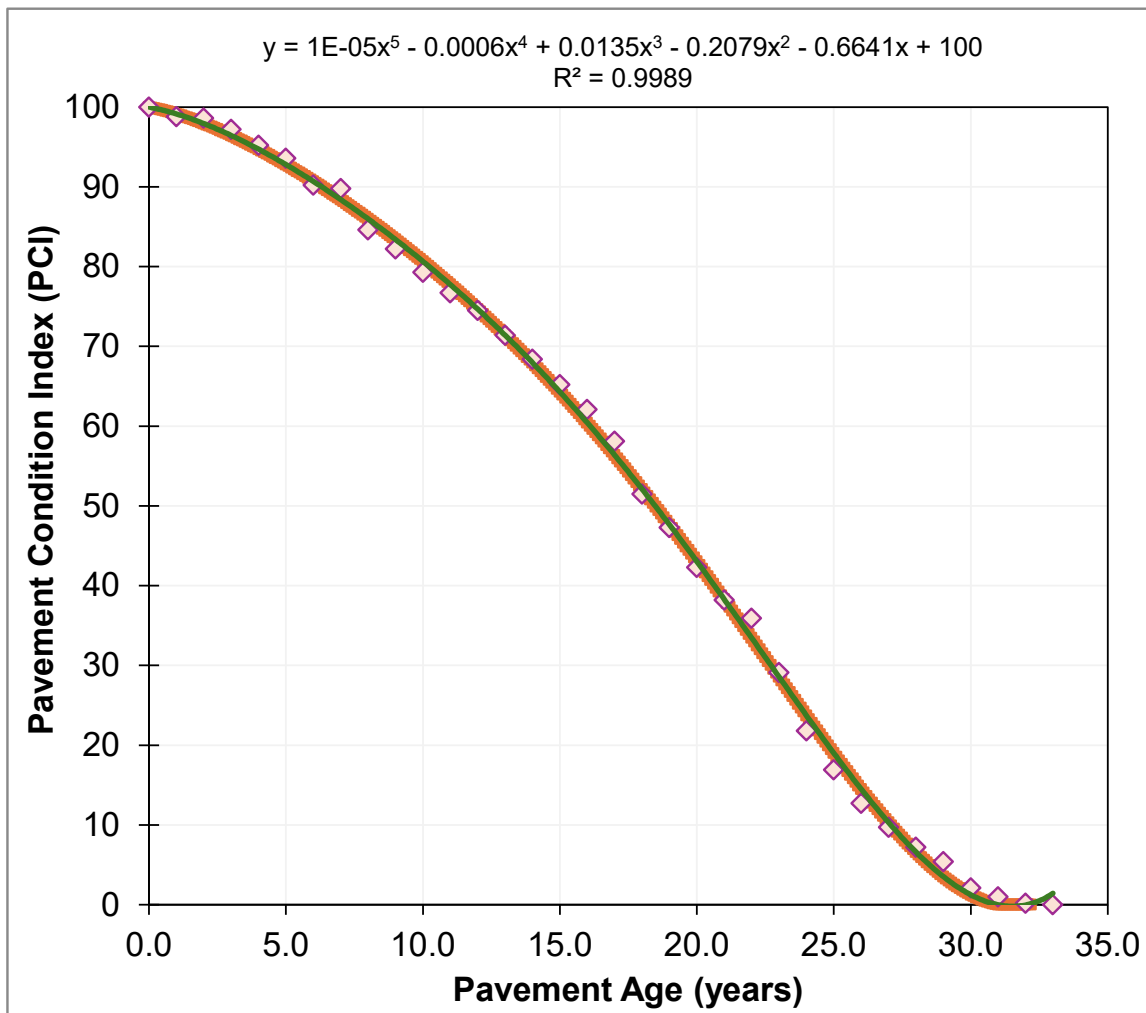
Figure 24: Pavement Performance Model

Pavements experience deterioration over time due to factors such as traffic loads, traffic volume, pavement structure, materials, and subgrade conditions. The rate of deterioration varies, prompting the classification of pavements with similar characteristics into distinct 'families' for management purposes. To manage these pavements effectively, deterioration models are developed for these groups. In the PAVER system, prediction models estimate future pavement conditions based on historical data. Accurate predictions necessitate knowledge of the pavement section's age, which is defined as the time elapsed since its last major maintenance or rehabilitation. Deterioration rates are classified as high if they exceed PCI 4 points per year for asphalt pavements (since the last construction) or PCI 5 points per year (since the last inspection), and more than PCI 2.5 points per year for concrete pavements.

In this analysis, due to the unavailability of historical data, ARA utilized an initial performance model used for small agencies on other projects. This performance model will be updated based on PCI scores from future surveys once they are performed.

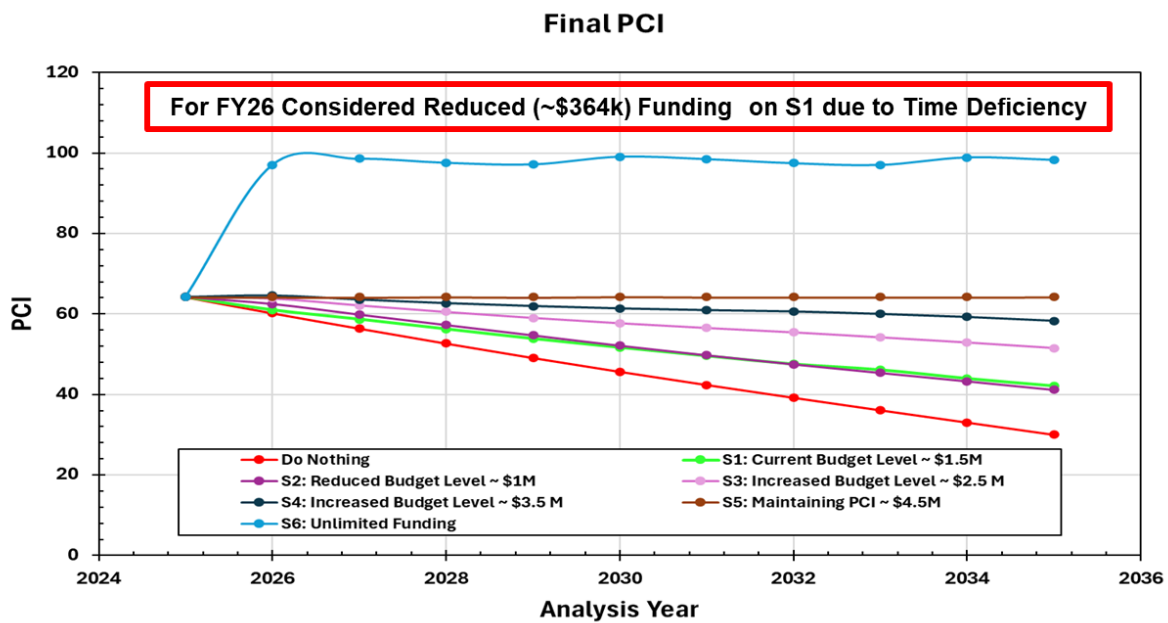
Figure 25: Overall Roadway Pavement Conditions Change over Time at Different Budget Level

The results of the budget analyses are shown in the following figures. Figure 25 illustrates the estimated 10-year change in pavement conditions resulting from the budget scenarios analyzed. This shows the impact of the current funding on the PCI score as well as the “Do Nothing” scenario, in which no repairs are considered, and the network continues to deteriorate. The impact of not maintaining the roadways results in approximately a 12-point PCI difference. Preventive maintenance such as Crack Sealing and major rehabilitation projects such as capital Reconstruction will help improve the overall network PCI. On the first year’s analysis only preventive measures were considered due to budget being already allocated to certain projects in FY 2026.

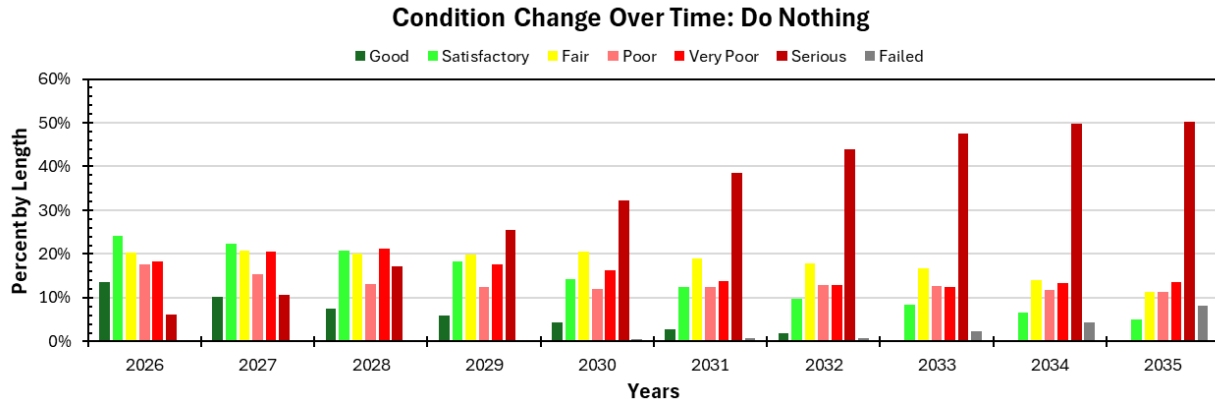
Figure 26: Do Nothing Scenario – Change in Pavement Condition over Time

Do-nothing scenario is an unrealistic scenario where no streets got any type of treatment in the next 10 years. The scenario provides a quantitative measure of how the city road would be if any measures are not taken into consideration. As per the analysis the city over all PCI would be 30.04 at the end of FY 2035. The change in condition is given in Table 8 & Figure 26.

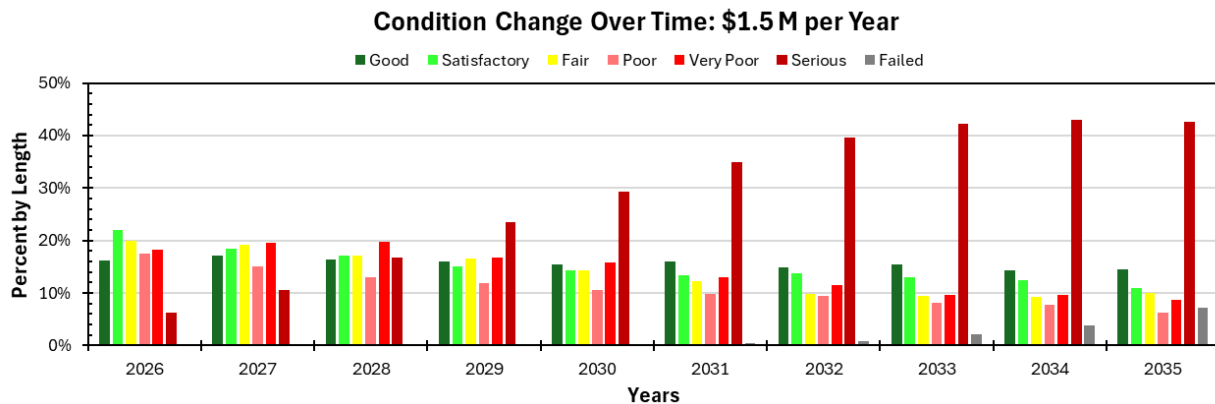
Figure 27: Current Funding Scenario – Change in Pavement Condition over Time

This scenario (S-1) estimates the condition changes over time while utilizing the city’s current funding (\$ 1.5M per year). The output from the S-1 is shown in Figure 27 & Table 9. As per the analysis, the network overall PCI will drop to 42.11 which implies the need for additional funding for the improvement of the network. Figure 28 presents the PCI map of the city after every treatment at the end of FY 2035.

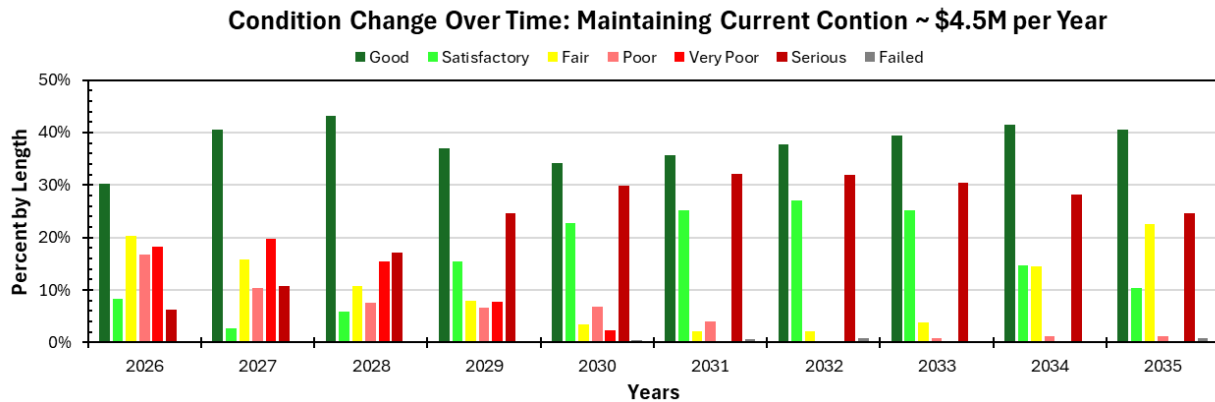
**Figure 31: Maintaining Current Condition – Change in Pavement Condition over Time**

Pavements naturally deteriorate over time, and maintaining their current condition requires applying treatments that offset annual declines in performance. When a network is already in good condition, this objective can typically be achieved through preventive maintenance strategies which are relatively low in cost. However, once the network drops into the fair or poor condition categories, restoring or even maintaining performance becomes substantially more difficult and significantly more expensive. This analysis also provides insight into the funding levels necessary to preserve network conditions over time. Based on the results, the city of Harker Heights requires approximately \$4.5 million per year within its pavement management program to maintain its current condition. The change in condition is presented in Figure 31 & Table 13.
